Manhole Inspection Summary

Manhole # S29KK1017MH

Insp Date: **4/30/07 9:41 AM**

Location Address: **301 NORTHFIELD PL**

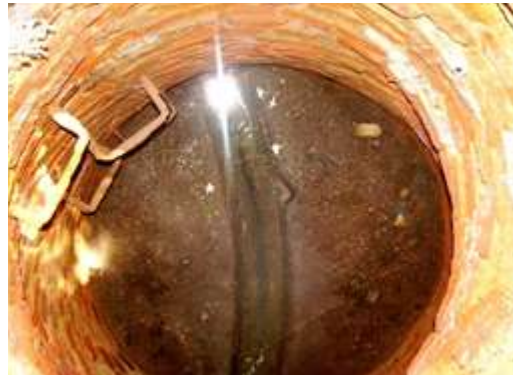
Top View

Corroded steps. Bench debris.

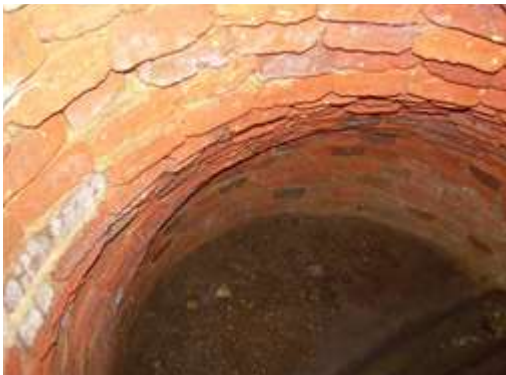
Defect

Adjustment and Corbel infiltration.

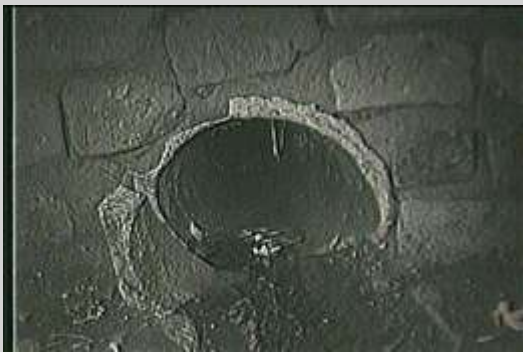
6 in. Circular Gravity Sewer Pipe Out @ 12 O'Clock

Infiltration: **Evidence** Pipe Seal Cond: **Unknown**

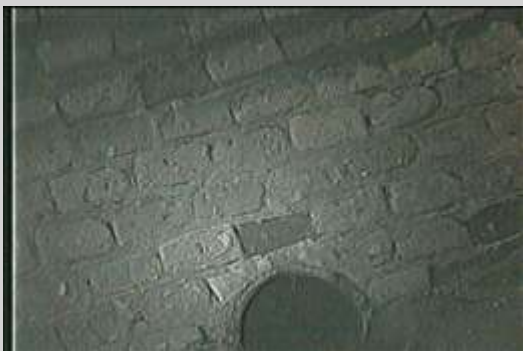
6 in. Circular Gravity Sewer Pipe In @ 6 O'Clock

Infiltration: **Evidence** Pipe Seal Cond: **Unknown**
